## INSPECTION REPORT

### 962 MODESTO S. LAKE TAHOE, CA

CLIENT'S NAME: ROMAN KREMINSKI  
DATE OF INSPECTION: JULY 3, 2008  
TIME OF INSPECTION: 10 AM  
INSPECTION #: 0081883

# Tahoe Certified Home Inspections, Inc.

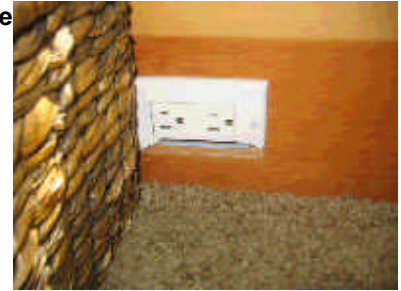
**OUTLETS:**

Functioning as designed. A broken cover plate is noted on the left side wall. Replacing the cover plate is recommended.

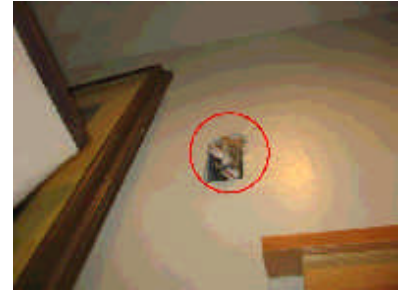
## ELECTRICAL:

Exposed wiring is noted in the closet. Adding a cover plate is recommended.

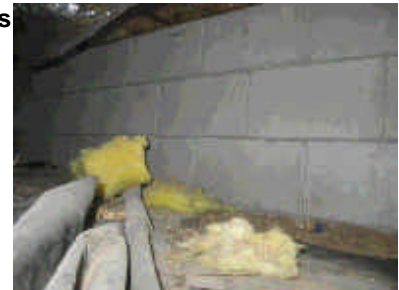
**METHOD OF INSPECTION:** I inspected the accessible areas.  
**ACCESS:** Garage.  
**STRUCTURE:** Visual condition is Good.  
**MATERIAL DETERIORATION:** No deterioration was identified by visual examination.  
**SUBFLOOR:** Plywood.  
**UNDER FLOOR INSULATION:** Yes. The floor insulation covers the framing and prevented the complete inspection of the subfloor and framing.  
**SOIL CONDITION:** Dry. A plastic moisture barrier is installed on top of the soil.  
**MOISTURE:** No evidence of current moisture entry was noted.  
**REMARKS:** Construction debris/trash is noted. Removal is recommended.
